**AFRL-ML-WP-TP-2006-477**

**COMPARISON OF X-RAY,  
MILLIMETER WAVE,  
SHEAROGRAPHY AND THROUGH-  
TRANSMISSION ULTRASONIC  
METHODS FOR INSPECTION OF  
HONEYCOMB COMPOSITES  
(PREPRINT)**

**AUGUST 2006**

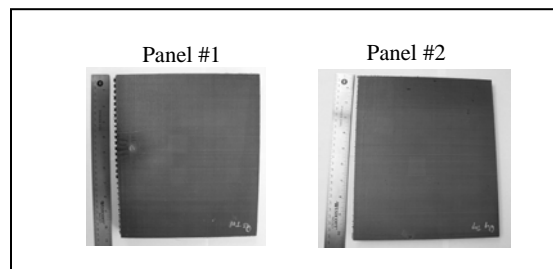
The first panel (Panel #1) is a 1" -thick honeycomb sample produced by stacking two 0.5"-thick honeycomb layers on top of one another with a mid-thickness composite septum separating the honeycomb layers. The second panel composite (Panel #2) was similarly manufactured except that it had a single layer of 0.5"-thick honeycomb core. Figure 1 shows pictures of these panels.

**Figure 1: Pictures of the two honeycomb composite panels.**

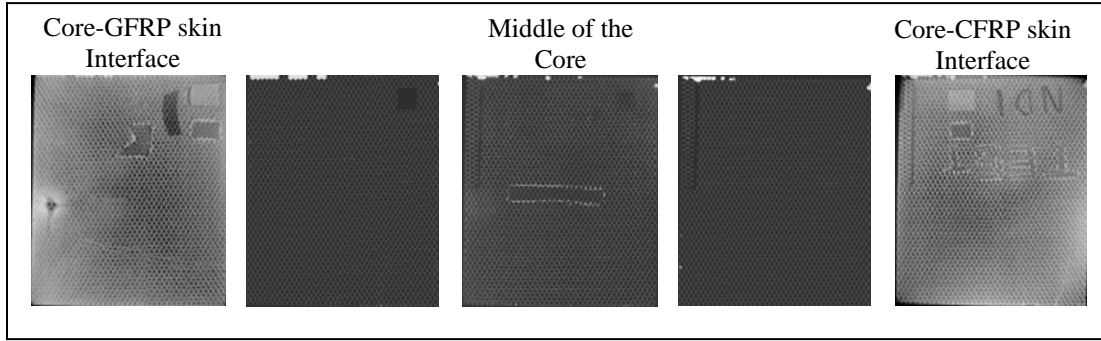
Figure 2 shows selected image slices of Panel #1 obtained using X-ray CT. The slices show different images as a function of depth within the panel thickness. As shown in the Figure 2, there are four subsurface flaws of different shapes appearing at the upper right-hand corner of the core-GFRP skin interface slice. A rectangular flaw is detected at the upper right-hand corner of the next slice shown. The image corresponding to the slice at the middle of the core shows one additional flaw in the panel septum. Finally, the core-CFRP skin interface slice reveals two rectangular flaws around the middle of the top portion of the panel (as well as the words “NDI TEST” engraved in the honeycomb at that depth).

Figure 2: X-ray CT image slices of Panel #1.

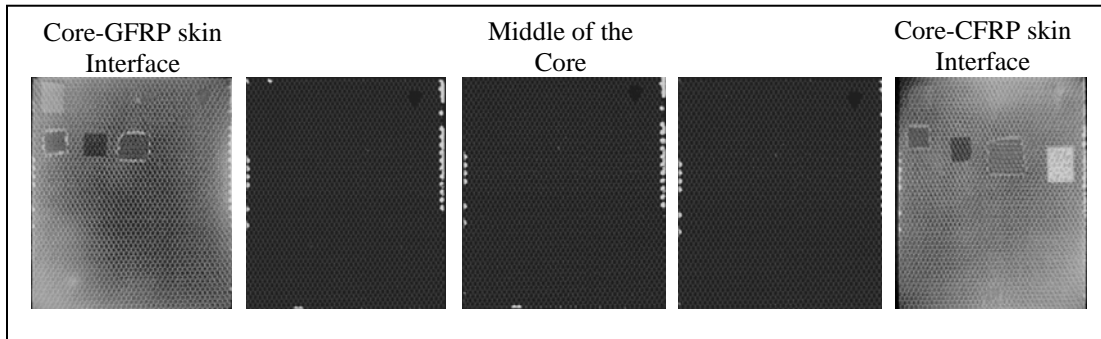
The X-ray CT sliced images of Panel #2 are shown in Figure 3. It is evident that most of the detected subsurface flaws are concentrated in the upper portion of the panel. The image slice corresponding to the core-GFRP skin interface shows four rectangular flaws at the upper left-hand side. Meanwhile, the middle slice indicates the presence of one flaw at the upper right hand corner. The image slice corresponding to the core-CFRP skin interface shows two additional rectangular flaws.

Figure 3: X-ray CT image slices of Panel #2.

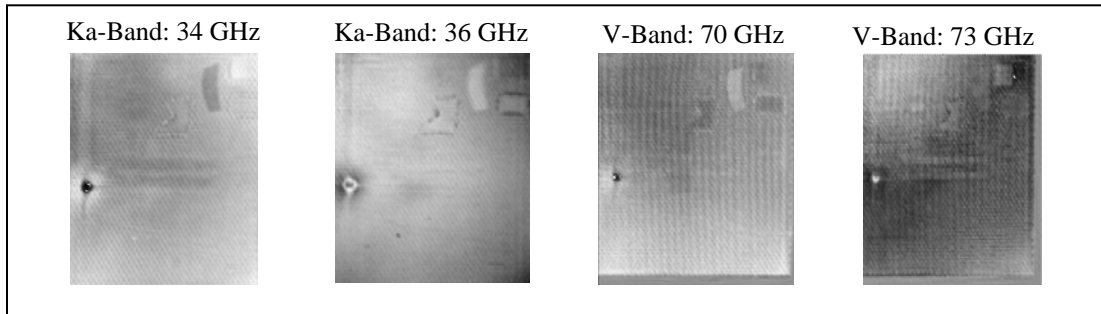
Figure 4 shows the corresponding images (raw) of Panel #1 at two different frequencies in the Ka- and V-band frequency ranges. The strong and localized indication near the left edge of the panel is due to a surface flaw and does not correspond to any of the embedded flaws. When comparing these images with those shown in Figure 2, it is interesting to note that specific embedded flaws are detected and their relative spatial allocations and sizes are also clearly indicated. Furthermore, flaws at different depths are detected at the same time and in the same imaging process (unlike slices in the X-ray CT images). This is an important practical issue. Generally, the V-band images show some flaws which are not a clearly indicated in the Ka-band images.

**Figure 4: Millimeter wave images of Panel #1 obtained at 34 GHz, 36 GHz, 70 GHz, and 73 GHz.**

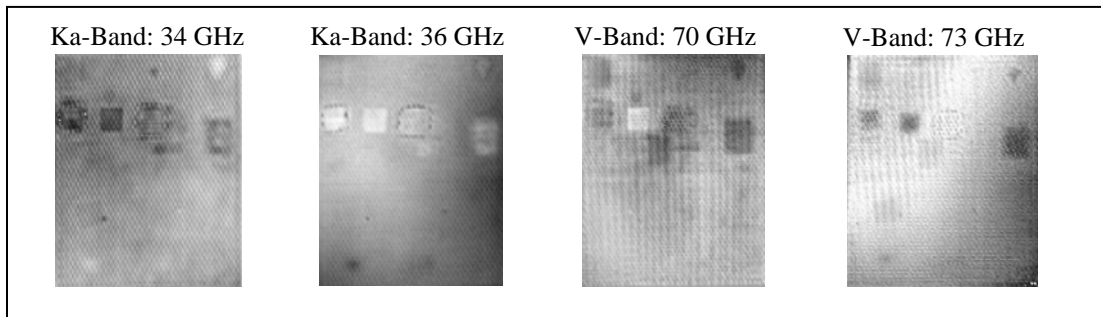
Figure 5 shows a set of similar images obtained from Panel #2. The same conclusions are made for this panel as those for Panel #1. Additionally, some overlapping flaws were also detected in these images (the 34 GHz and 70 GHz images). Comparing these results with those shown in Figure 3, it is clear that many of the flaws were detected even those that overlapped through the panel depth. Once again, the V-band images provided higher flaw detectability and resolution compared to the Ka-band images.

**Figure 5: Millimeter wave images of Panel #2 obtained at 34 GHz, 36 GHz, 70 GHz, and 73 GHz.**

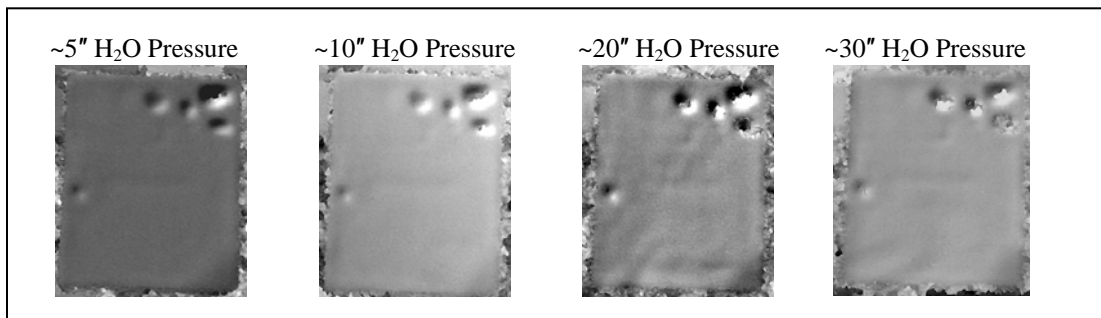
The images shown in Figure 6 - 8 were formed using different vacuum stress state values. Figure 6 shows the Shearography images of Panel #1 obtained using various vacuum pressure values applied at the GFRP skin side. Four subsurface flaws of different sizes are apparent at the top right corner of the panel. Hence, this technique detected 8 out of the 22 flaws detected in this panel. The exact shapes of the flaws, however, are not clear in the obtained image with respect to other NDT methods used in this investigation.

**Figure 6: Shearography images of Panel #1 using different pressure values applied at the GFRP skin side.**

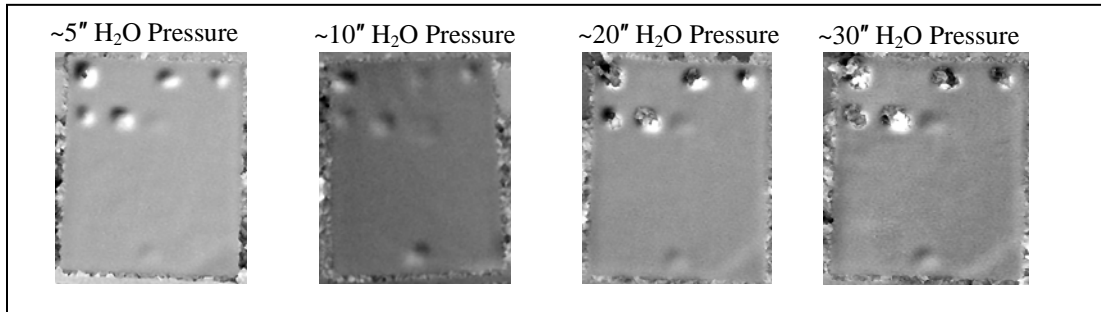
The same pressure values were used to capture shearography images of Panel #2. The pressure was applied at the GFRP side first then at the CFRP side. Figure 7 and Figure 8 show the resulting images, respectively. Collectively, both images indicated the presence of 8 out of 15 flaws. Again, the shapes of the detected flaws are not well defined in these images.

**Figure 7: Shearography images of Panel #2 using different pressure values applied at the GFRP skin side.**

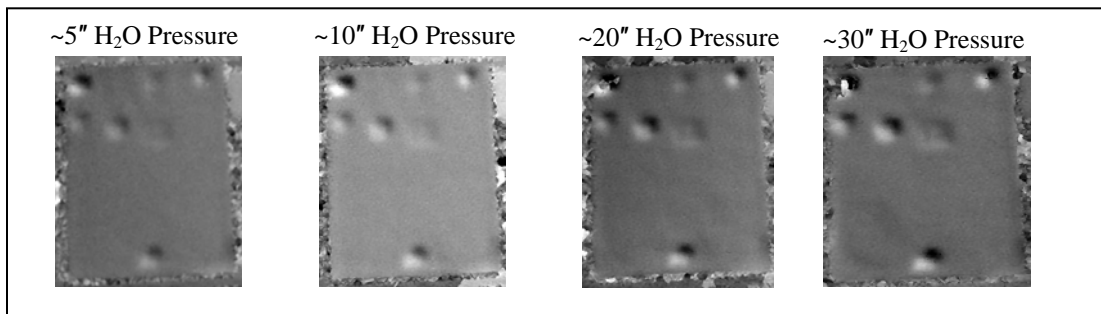
**Figure 8: Shearography images of Panel #2 using different pressure values applied at the CFRP skin side.**

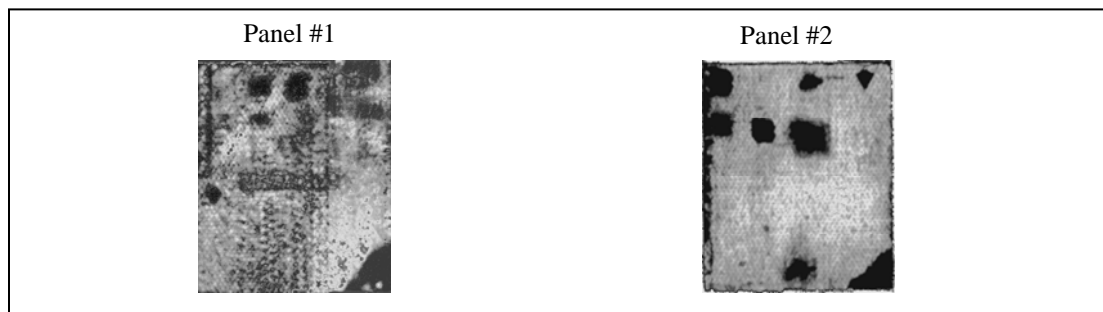
Figure 9 shows the TTU images of Panels #1 and #2 obtained at 5 MHz with scanning resolution of 0.01". The image obtained from Panel #1, distinctly indicates the presence of 16 out of the 22 subsurface flaws. The flaws in the upper right hand corner are blurred and difficult to individually distinguish. Unfortunately, the sound propagation is restricted in a TTU inspection through a double layer honeycomb sample with a septum, such as Panel #1. This is due to the misalignment of the honeycomb layers, in which the sound energy depends on to optimally carry the energy through the sample. As for Panel #2, the obtained image clearly shows 8 subsurface flaws out of possible 15. Furthermore, the shapes of the detected flaws can be readily determined in the image.

**Figure 9: Through-transmission ultrasound images of Panels #1 and #2.**
